**ASTM E 90 SOUND TRANSMISSION LOSS  
TEST REPORT**

**MASONITE INNOVATION CENTER**

**SERIES/MODEL: Rediframe**

**TYPE: Side-Hinged Single Door**

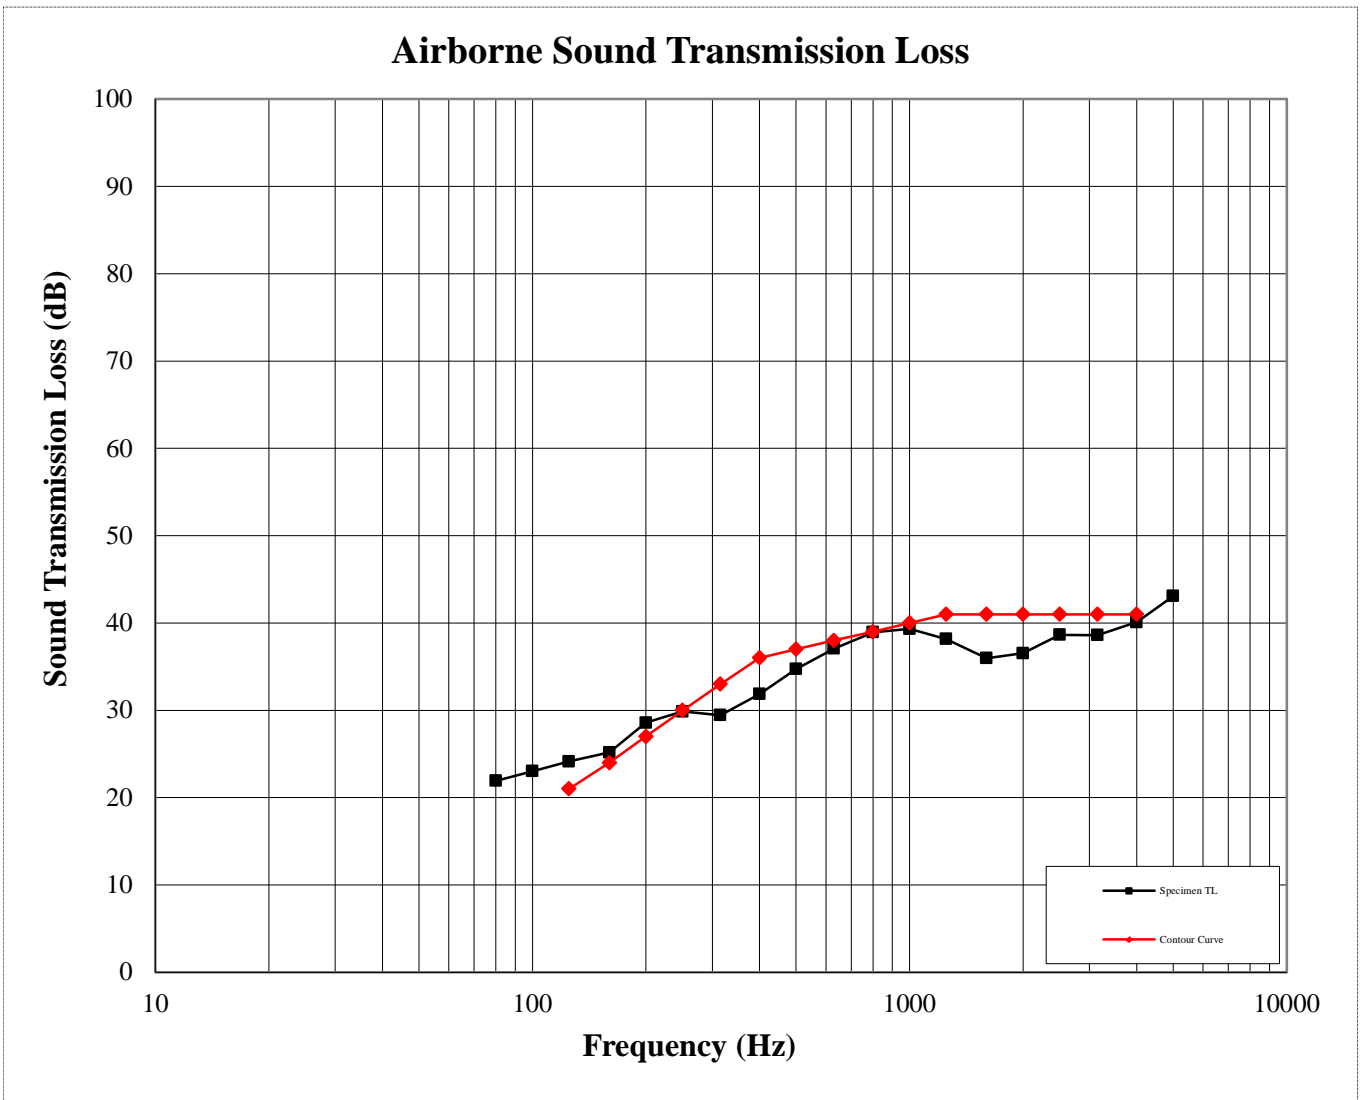
<b>Test Date</b>	01/13/15					
<b>Data File No.</b>	E2104.01A					
<b>Client</b>	Masonite Innovation Center					
<b>Description</b>	Series/Model: Rediframe, side-hinged single door system, sealed with duct seal on both sides (inoperable)					
<b>Specimen Area</b>	2.24 m <sup>2</sup>	Receive Temp.	23.8 °C		Source Temp.	23.9 °C
<b>Technician</b>	Eric A. Thomps	Receive Humidity	46%		Source Humidity	48%

**STC Rating**      **37**      *(Sound Transmission Class)*  
**Deficiencies**      29      *(Sum of Deficiencies)*  
**OITC Rating**      **32**      *(Outdoor-Indoor Transmission Class)*

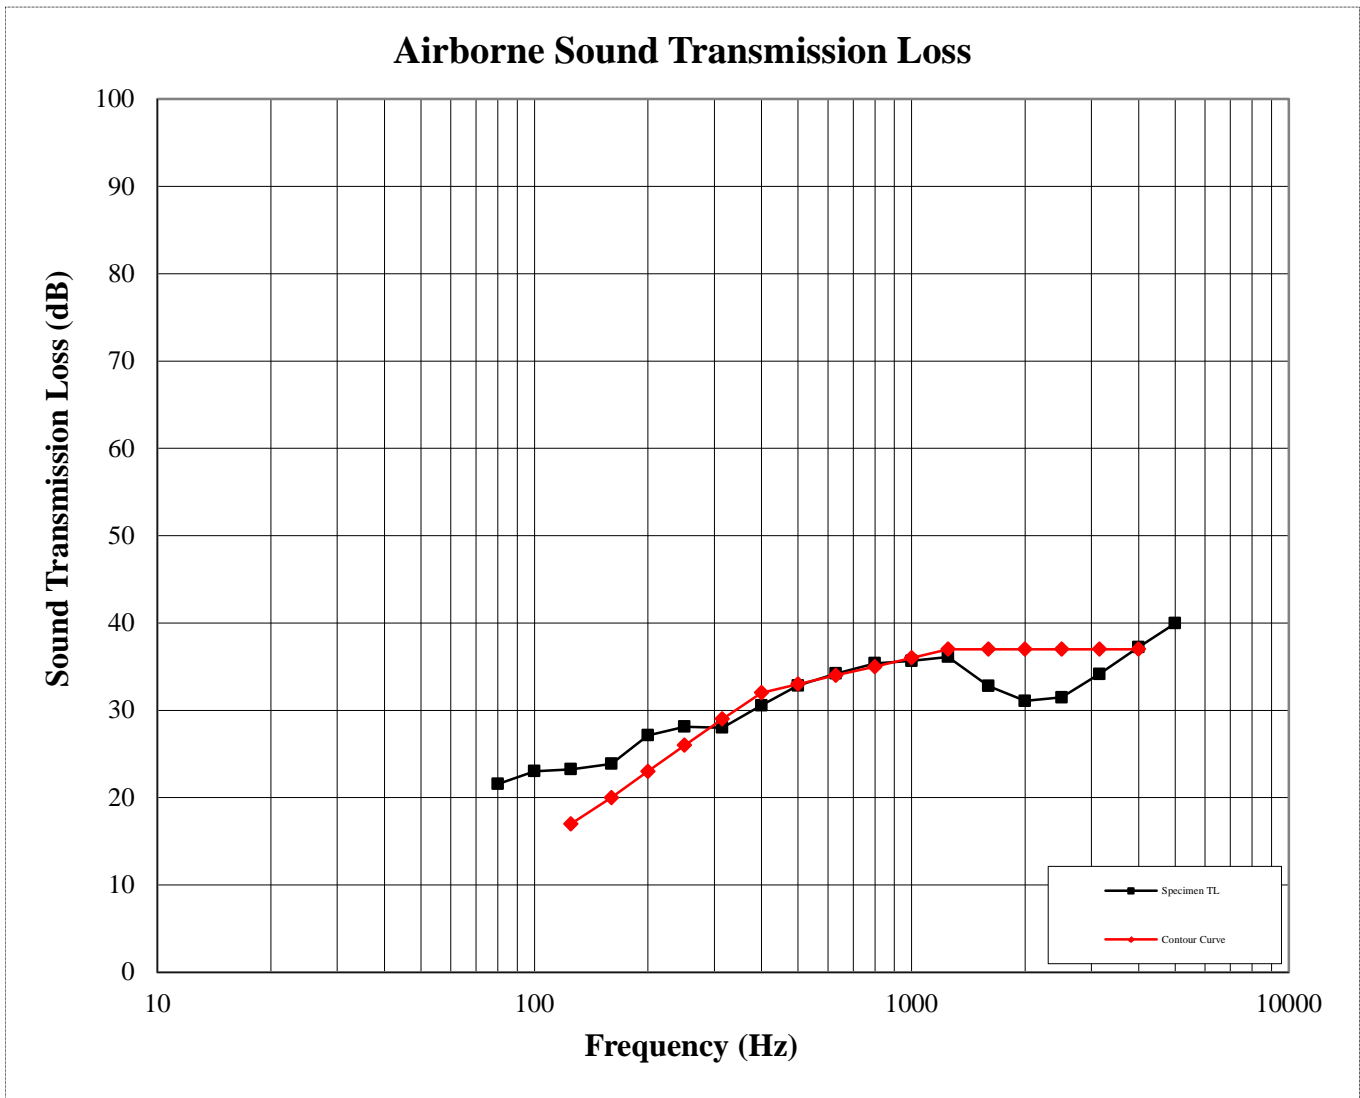
<b>Test Date</b>	01/13/15					
<b>Data File No.</b>	E2104.01B					
<b>Client</b>	Masonite Innovation Center					
<b>Description</b>	Series/Model: Rediframe, side-hinged single door system, with Zero International Seals 8150S one row on head and jambs, 369AA mortised door bottom (operable)					
<b>Specimen Area</b>	2.24 m <sup>2</sup>	Receive Temp.	23.8 °C		Source Temp.	23.9 °C
<b>Technician</b>	Eric A. Thomps	Receive Humidity	46%		Source Humidity	48%

**STC Rating**        **33**        *(Sound Transmission Class)*  
**Deficiencies**        **22**        *(Sum of Deficiencies)*  
**OITC Rating**        **30**        *(Outdoor-Indoor Transmission Class)*

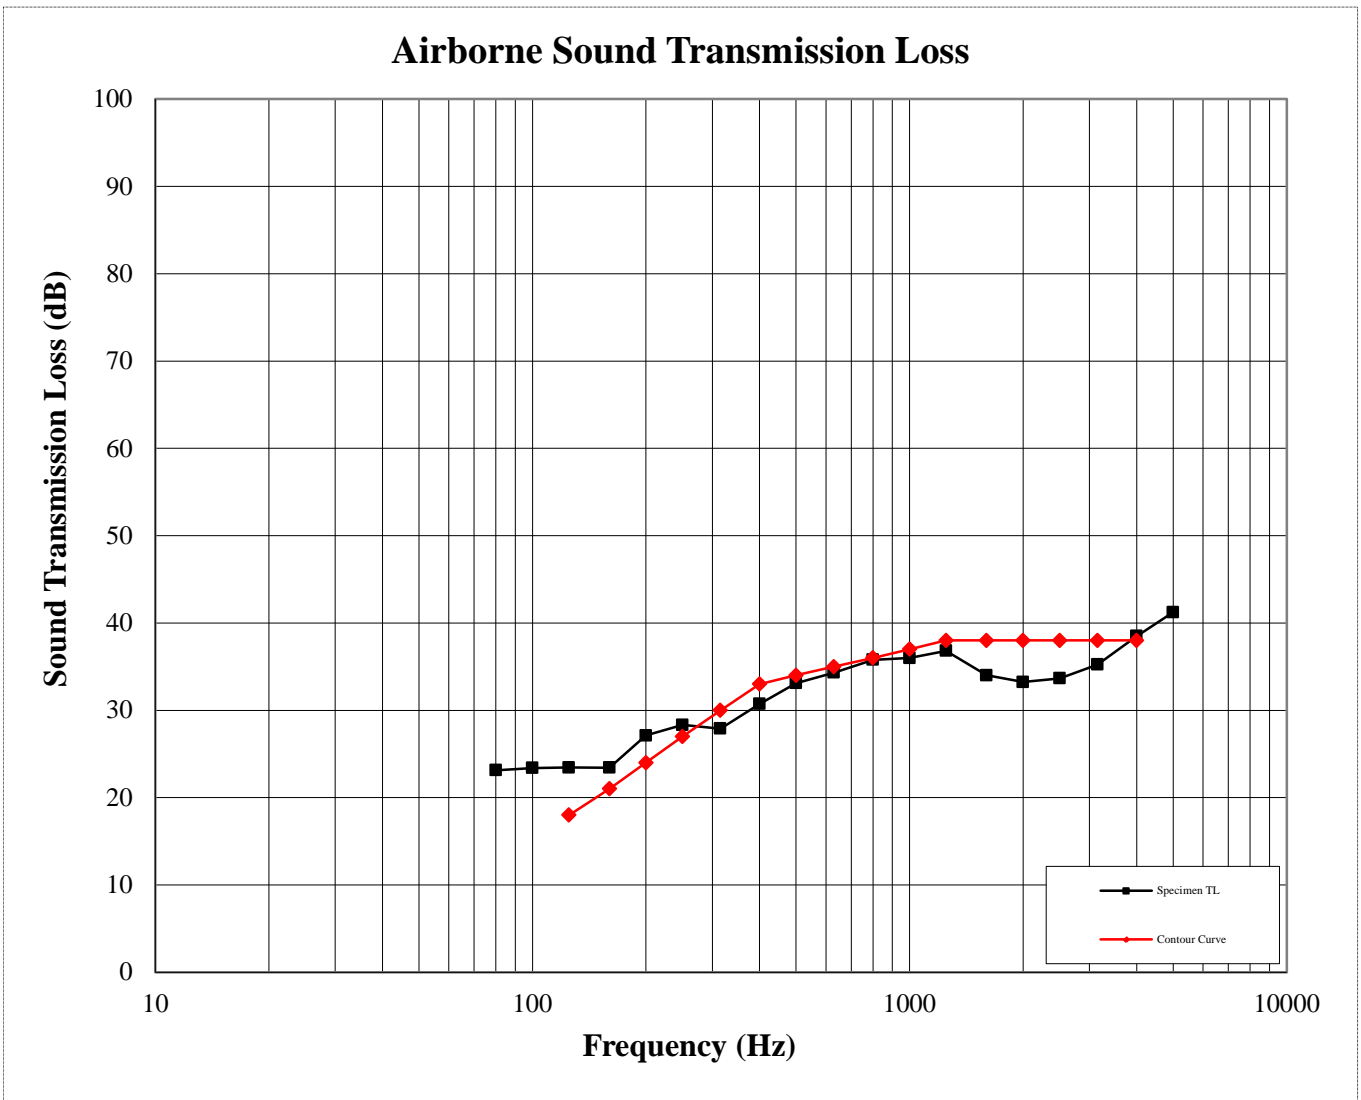
Test Date	01/13/15					
Data File No.	E2104.01C					
Client	Masonite Innovation Center					
Description	Series/Model: Rediframe, side-hinged single door system, with Zero International Seals 8150S one row on head and jambs, 188S one row on head and jambs, 369AA mortised door bottom (operable)					
Specimen Area	2.24 m <sup>2</sup>	Receive Temp.	23.8 °C		Source Temp.	23.9 °C
Technician	Eric A. Thomps	Receive Humidity	46%		Source Humidity	48%

**STC Rating**        **34**        *(Sound Transmission Class)*  
**Deficiencies**        **24**        *(Sum of Deficiencies)*  
**OITC Rating**        **30**        *(Outdoor-Indoor Transmission Class)*

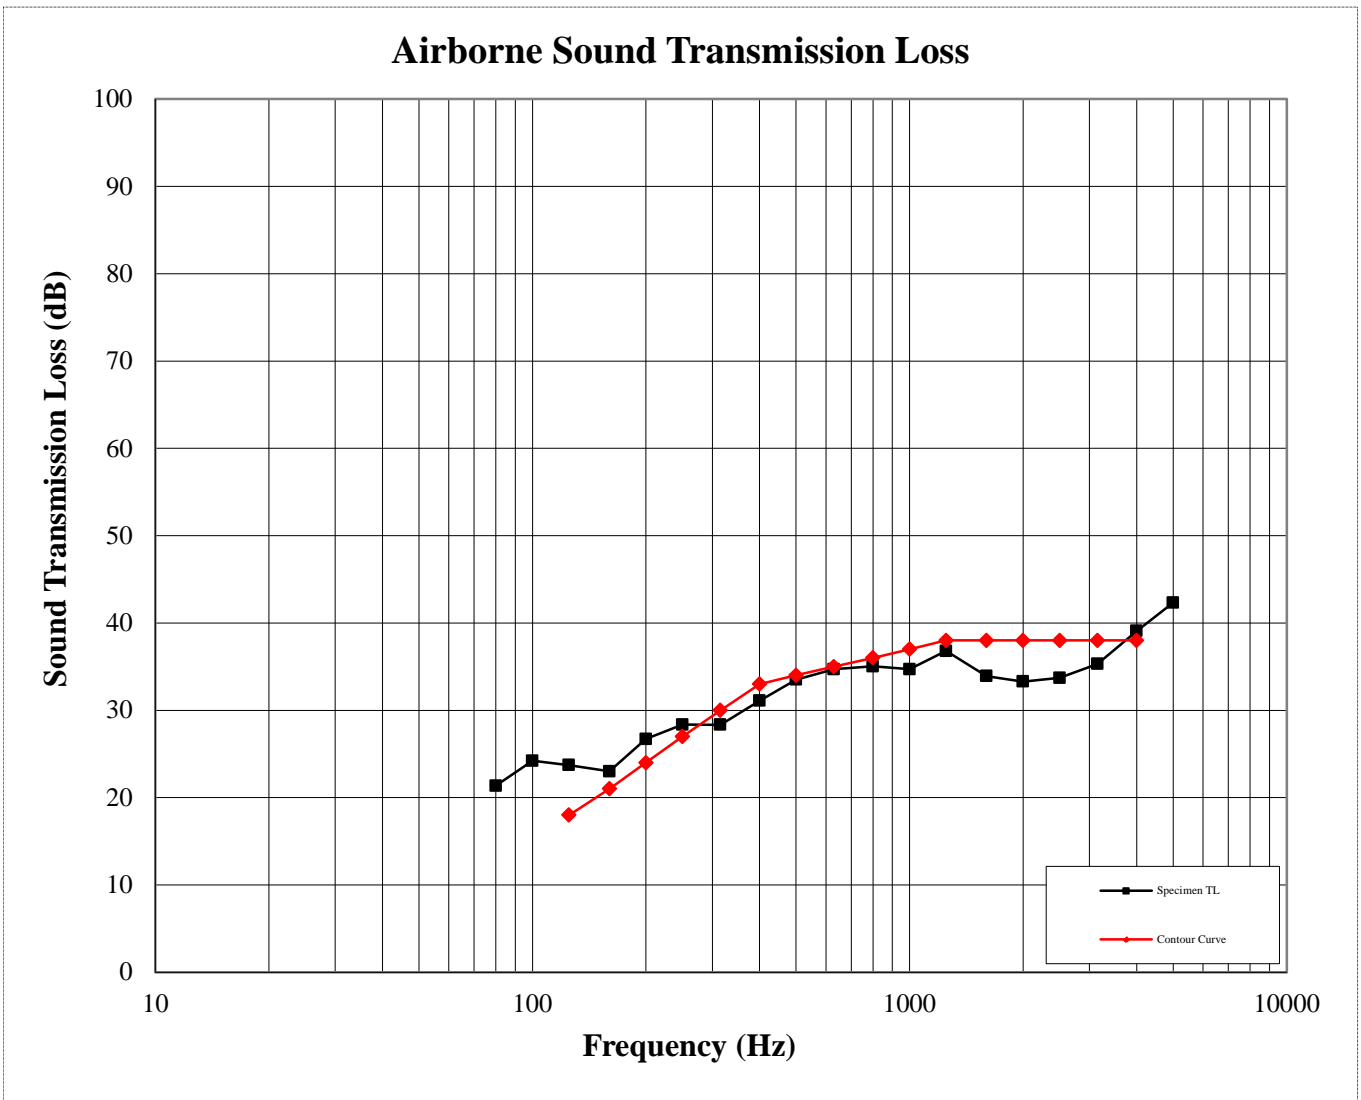
<b>Test Date</b>	01/13/15					
<b>Data File No.</b>	E2104.01D					
<b>Client</b>	Masonite Innovation Center					
<b>Description</b>	Series/Model: Rediframe, side-hinged single door system, with Zero International Seals 8150S one row on head and jambs, 188S one row on head and jambs, 369AA mortised door bottom, 564A threshold (operable)					
<b>Specimen Area</b>	2.24 m <sup>2</sup>	Receive Temp.	23.8 °C		Source Temp.	23.9 °C
<b>Technician</b>	Eric A. Thomps	Receive Humidity	46%		Source Humidity	48%

**STC Rating**      **34**      *(Sound Transmission Class)*  
**Deficiencies**      24      *(Sum of Deficiencies)*  
**OITC Rating**      **30**      *(Outdoor-Indoor Transmission Class)*

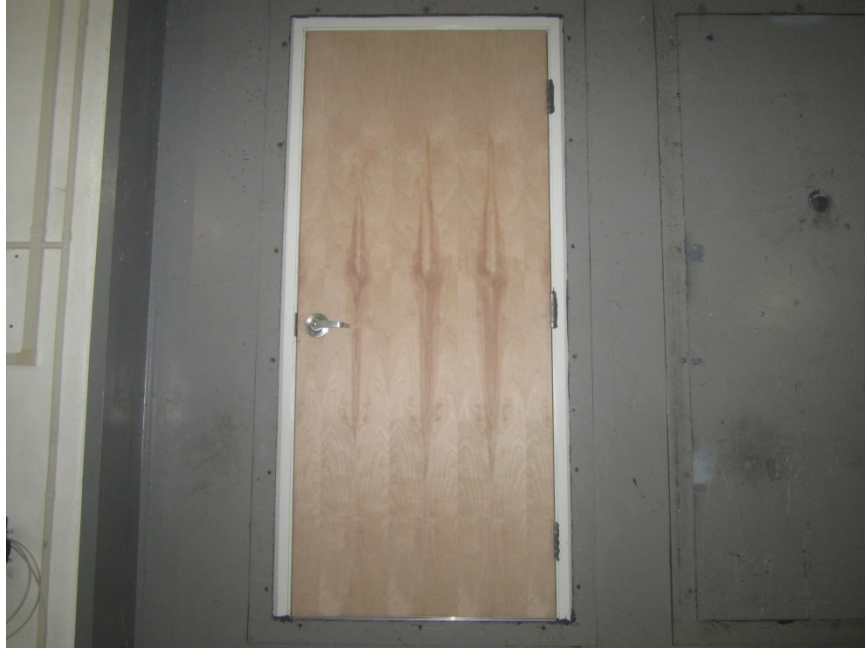
**Receive Room View of an Installed Test Specimen**

The specimen plug was removed from the filler wall assembly. The door system was placed on a foam isolation pad in the test opening. Duct seal was used to seal the perimeter of the test specimen to the test opening on both sides. The interior side of the door frame, when installed, was approximately 1/4" from being flush with the receiving room side of the filler wall. A stethoscope was used to check for any abnormal air leaks around the test specimen prior to testing.

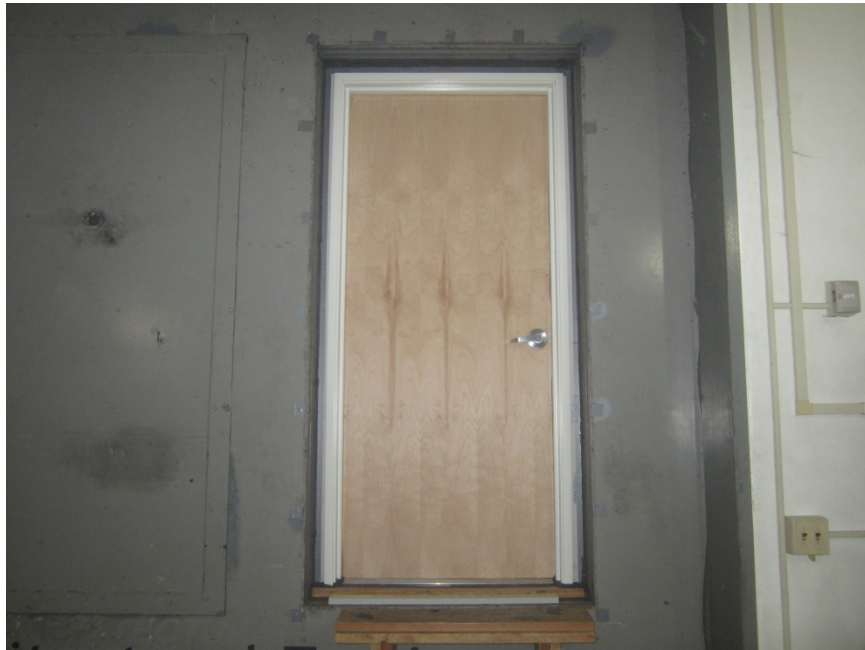
**Source Room View of an Installed Test Specimen**
